**2024 Annual Landfill Inspection under
Coal Combustion Residuals Rule
Seminole Generating Station
Putnam County, Florida**

March 15, 2024

Subject: 2024 Annual Landfill Inspection under Coal Combustion Residuals Rule, Seminole
Generating Station, Putnam County, Florida

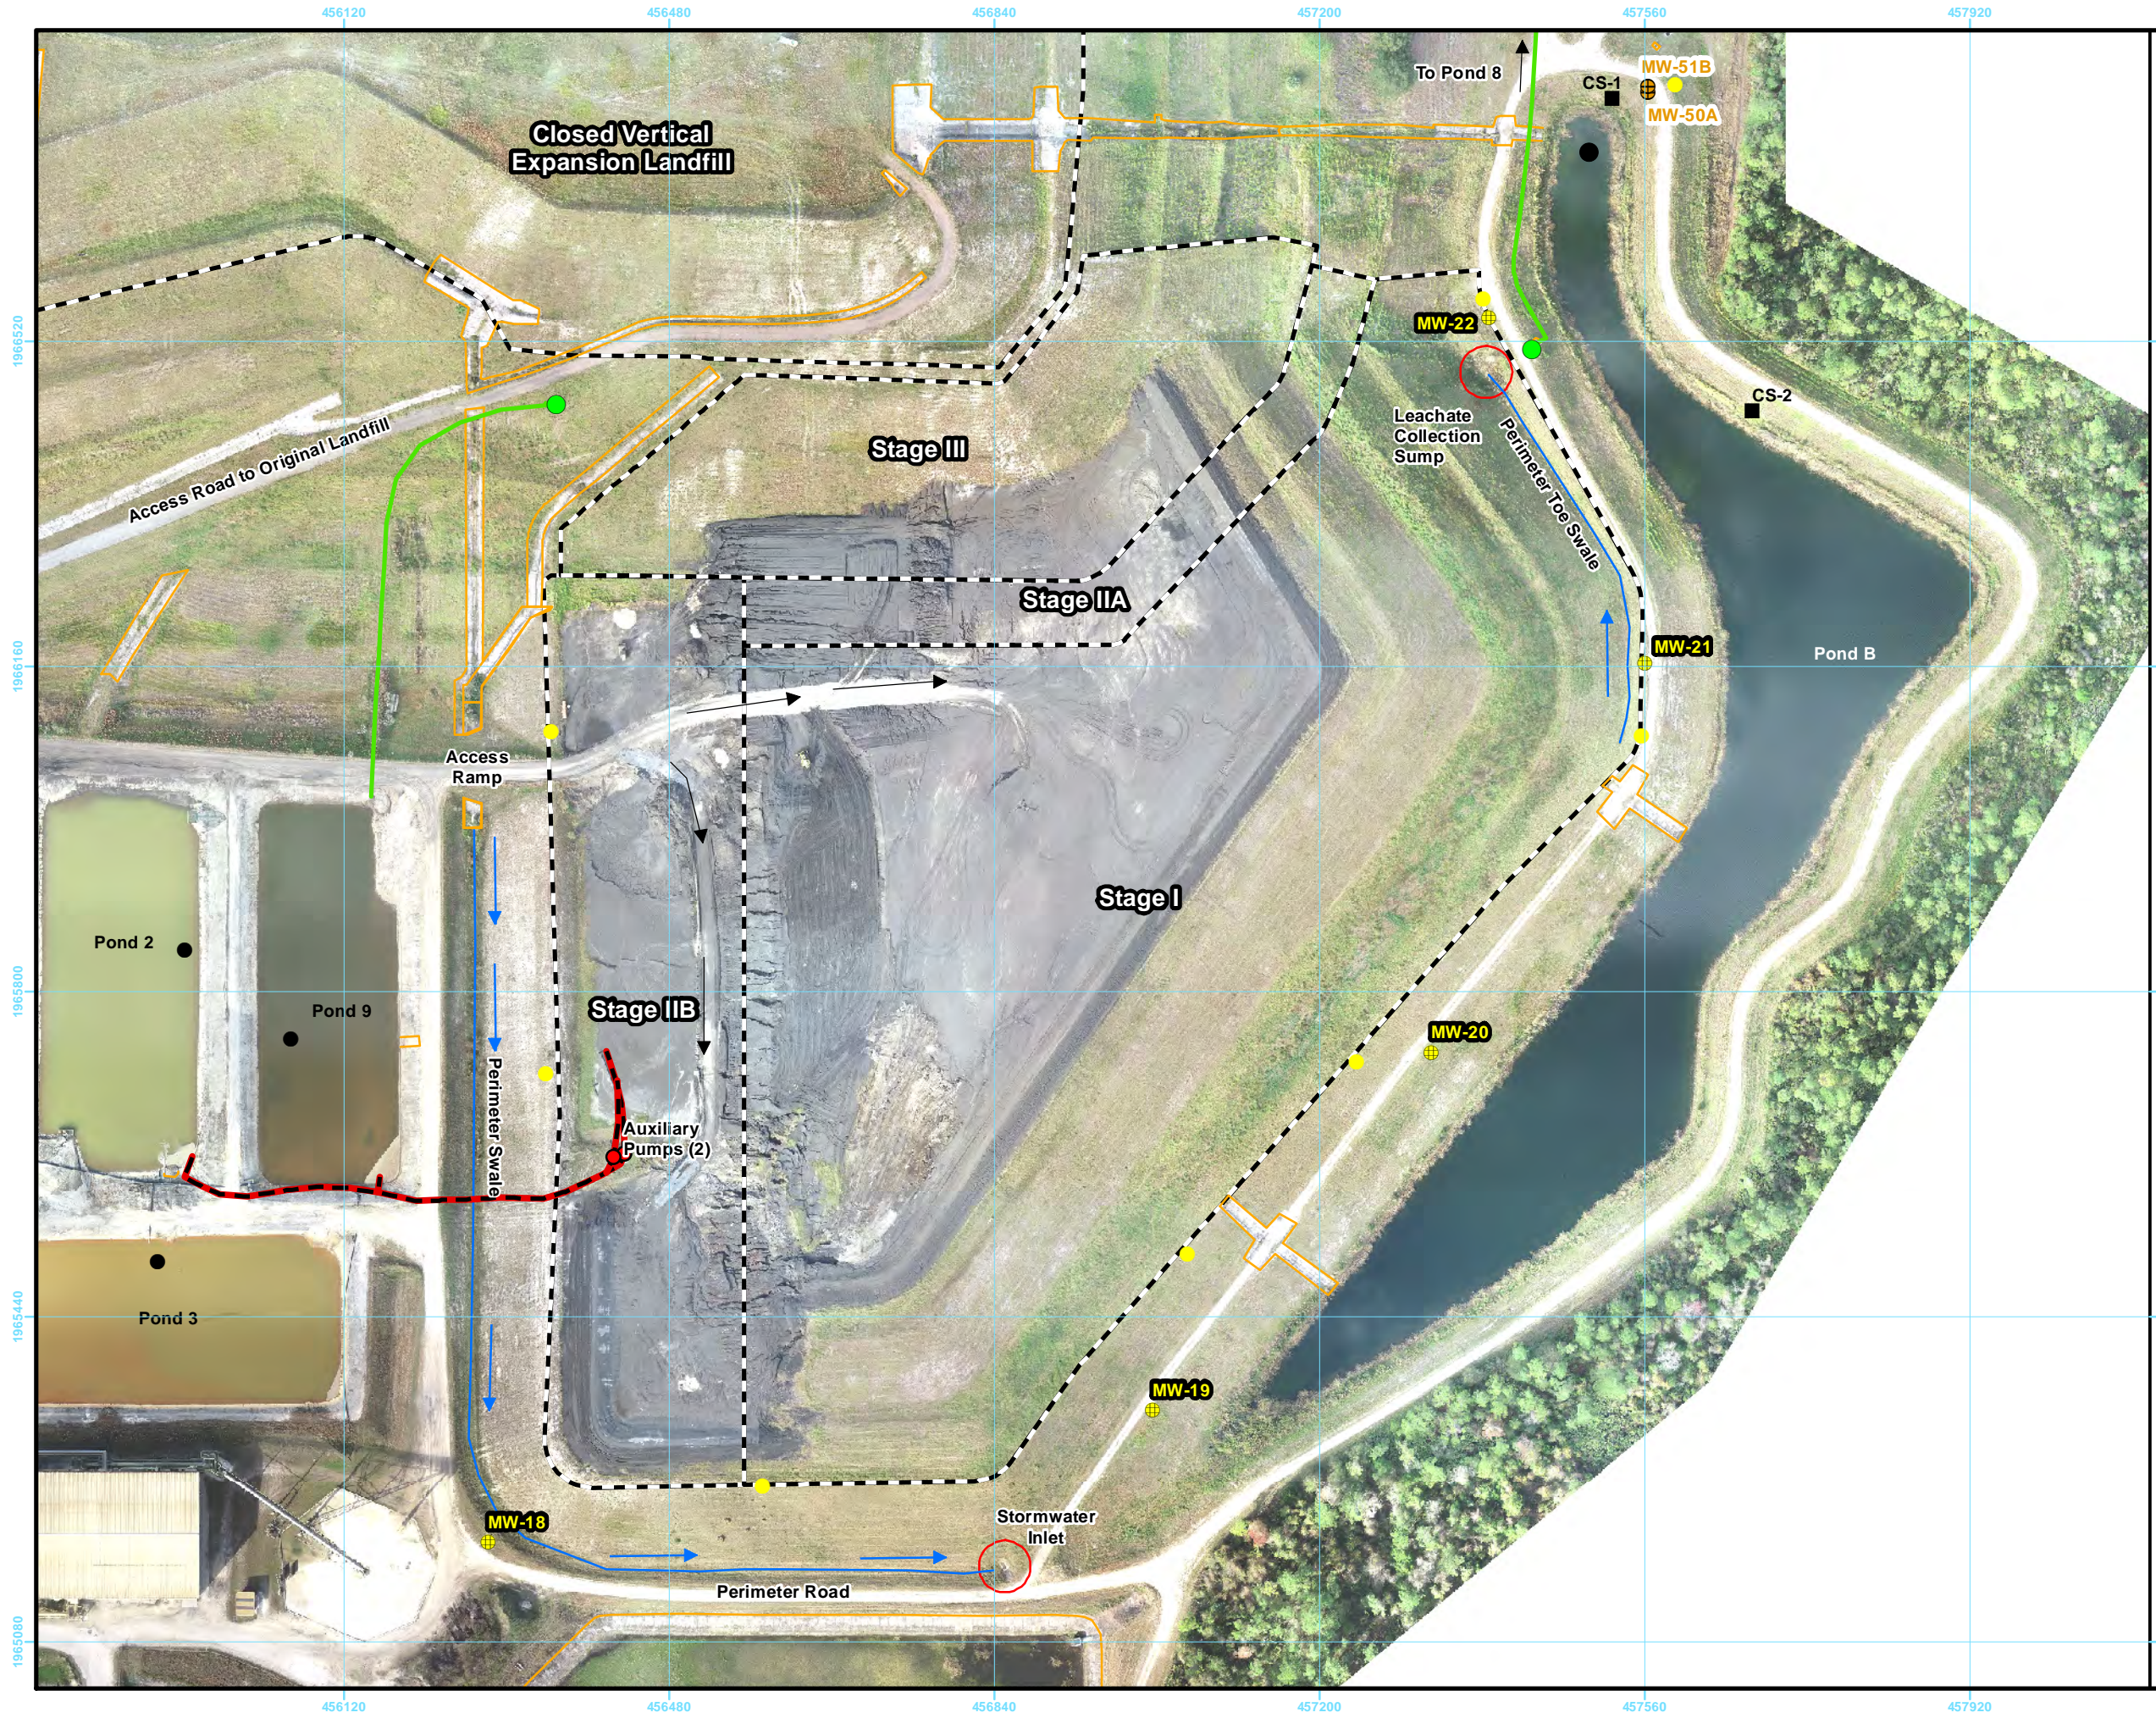
An annotated December 5, 2023 aerial photograph with the items observed during our inspection is shown in Figure 5. Selected representative photographs taken during the site inspection on January 19, 2023 are included in Appendix 1.

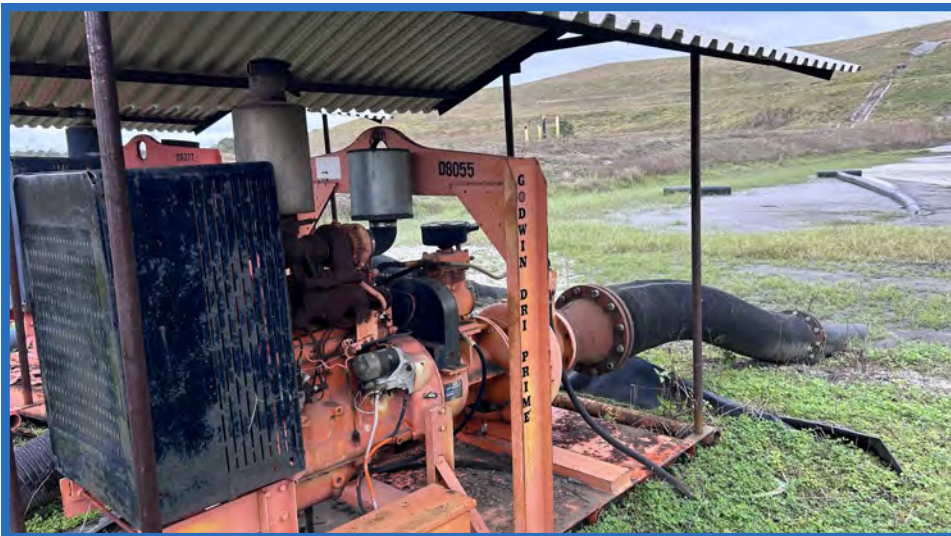
at the low point of Stage IIB where the intake pipes for the two auxiliary pumps are deployed was holding a small amount of rain water. According to Seminole, waste has not yet been placed in this area and the accumulated sediment from run-off was periodically removed to expose the drainage sand. Even with the sediment deposited over the drainage sand, run-off gradually infiltrated into the leachate collection system.

Auxiliary Pumps with Intake Pipelines in Low Point of Stage IIB

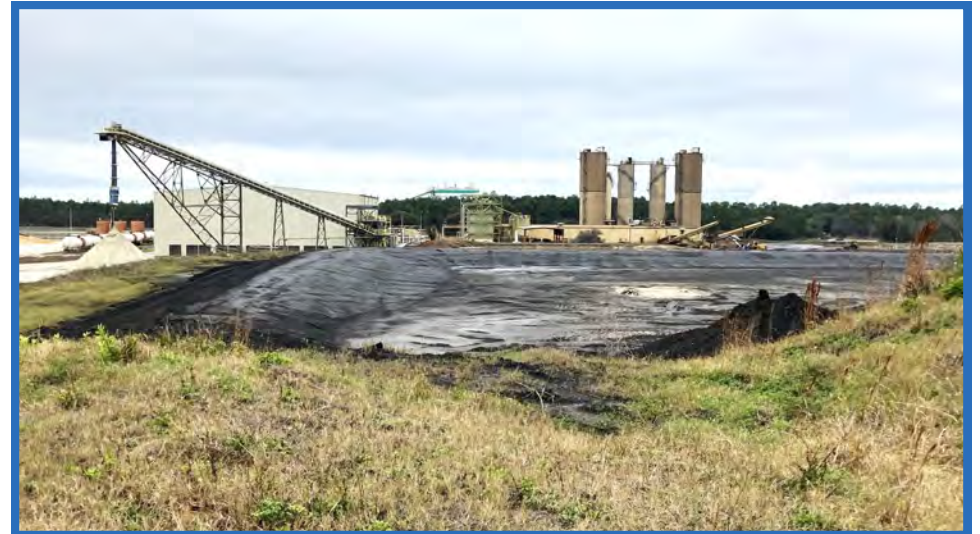
A pozzocrete dike had been constructed above the existing bench in the southern part of Stage IIB. The area inside the dike was graded toward the low point of Stage IIB where the auxiliary pump intakes are deployed. The benches along the southern and western sides of Increment 1 and the adjacent side slopes were observed to be in good condition. The pozzocrete dike on the east side of the Stage I area had reached an elevation of approximately +140 to +148 feet (NAVD88). All but the upper 15 to 20 feet of the pozzocrete dike above the highest bench had been covered with soil and grassed. The benches below the dike at elevations of approximately +135 feet and +115 feet (NAVD88) and the adjacent side slopes were covered with soil and grass. The waste at the top of Stage I was generally sloped in a westerly direction toward the Stage IIB area.

Pozzocrete Dike in Southern Part of Stage IIB, Looking West

- The remaining 15 to 20 feet of upper pozzocrete dike on the southern and eastern sides of Increment 1 should be covered with soil and seeded as soon as conditions permit.

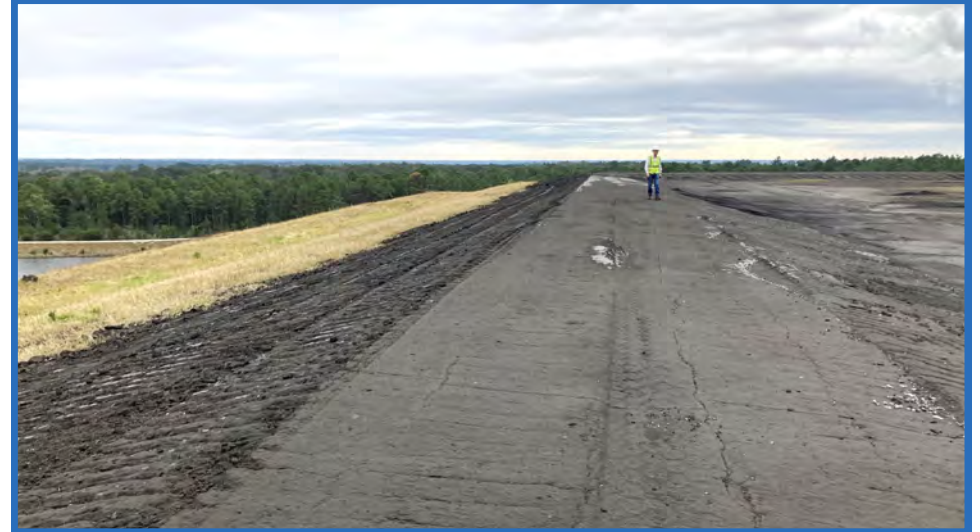
Pozzocrete Dike at Top of Waste on Eastern Side of Stage I,
Looking South Along Dike

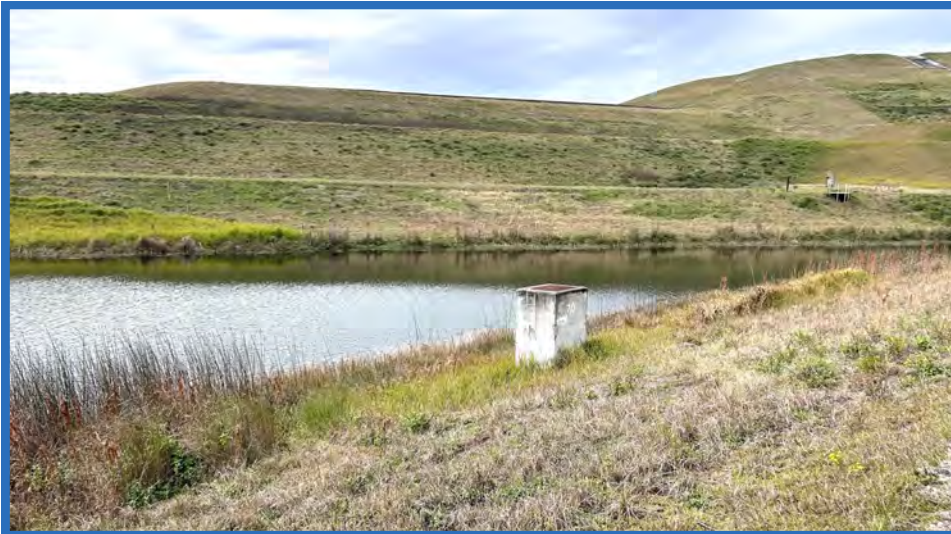
Stormwater Pond B and the perimeter road around the east side of the pond were in good condition. The CS-1 and CS-2 outlet structures were clear and unobstructed. The water level in Pond B was well below the overflow or bleed down elevations.

Outlet Structure CS-2 for Stormwater Pond B, Looking West from
Perimeter Road Around Eastern Side of Pond B

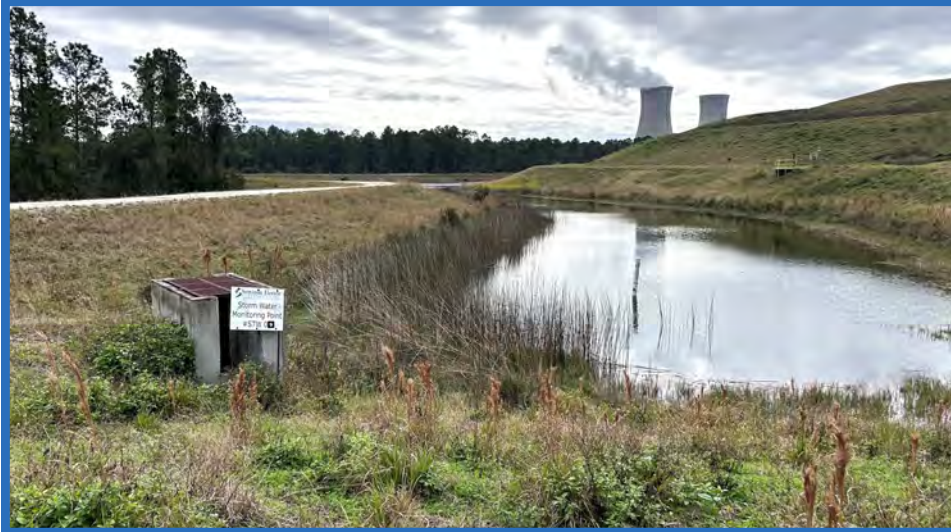
Outlet Structure CS-1 and Staff Gauge for Stormwater Pond B, Looking South

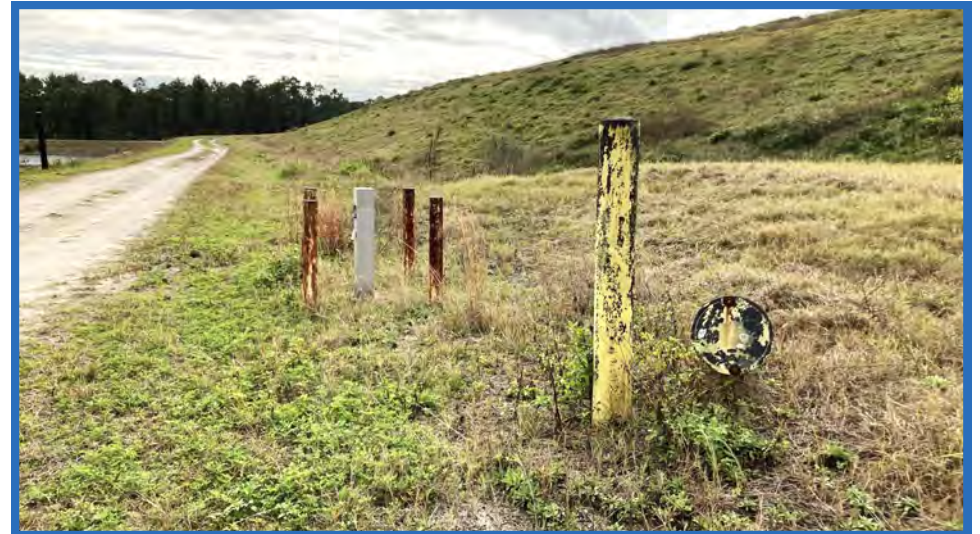
The four leachate collection system cleanouts and four monitor wells (MW-19 through MW-22) on the east side of Increment 1 were in good condition and protected by bollards painted yellow or white for visibility. All of the monitor wells had labels or metal tags showing the well number, measuring point elevation, and depth. The swale within the lined containment that drains toward the sump was unobstructed and had good grass cover. No standing water was observed in the swale or the sump. The two Fabriform-lined flumes and stilling basins draining into Pond B on the east side of Increment 1 were in good condition, with minor amounts of sediment and no water collected at the low points of the road crossings.

Monitor Well MW-22 and Leachate Collection System Cleanout East of Perimeter Road, Looking South with Stormwater Pond B to the Left

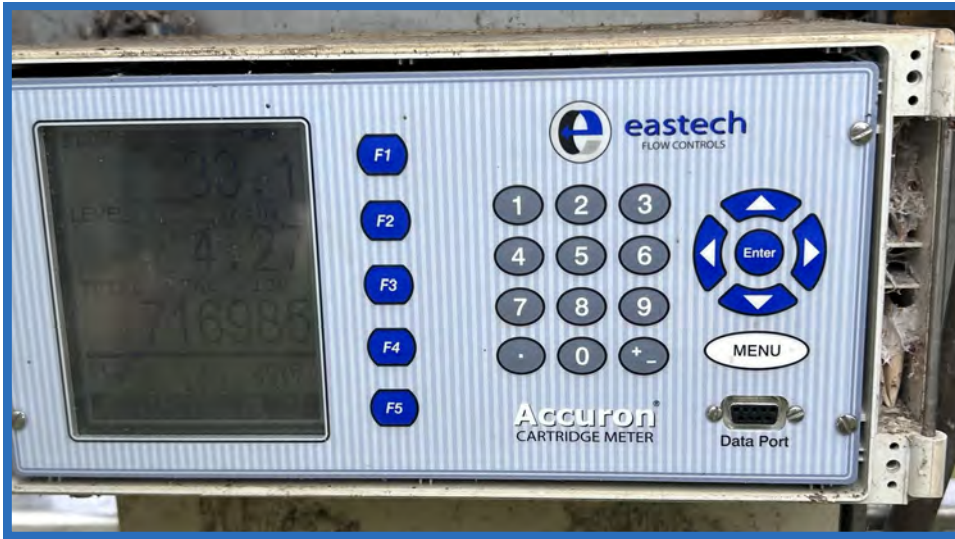
The leachate collection manhole for Increment 1 and the leachate flow meter appeared to be functioning properly. At the time of our inspection, the leachate collection control panel displayed a totalizer reading of 716985 x100 gallons and a flow rate of 33.1 gpm. The leak detection meter indicated no flow. The Fabriform-lined flume on the eastern slope of the closed original landfill just north of Increment 1 discharges into the north end of Pond B. This flume had been extended to the top of the vertical expansion as part of closure construction for the vertical expansion.

Leachate Collection Flow Meter Control Panel for Increment 1

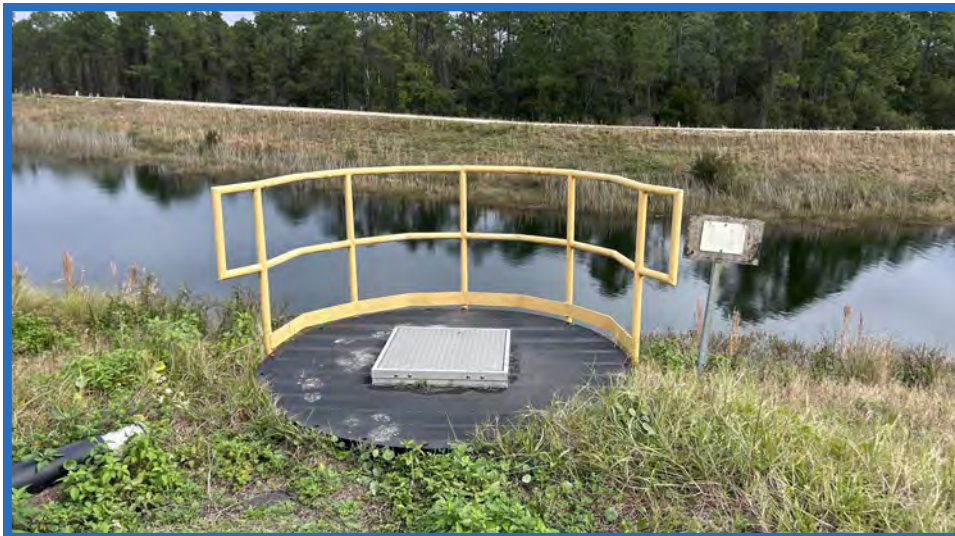
Leachate Collection and Leak Detection System Manhole for Increment 1

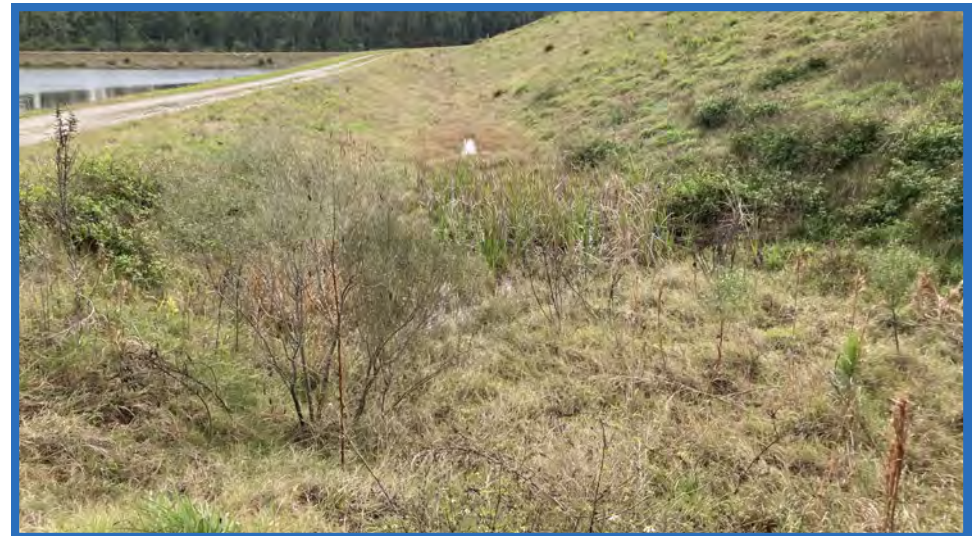
Sump Area of Increment I and Perimeter Swale East of Stage I, Looking Southwest

- Seminole should continue to monitor vegetation growth in the drainage sand/protective cover and remove vegetation that has the potential to damage the liner or clog the leachate collection system. This includes vegetation in the sump and perimeter toe swale area on the east side of the Stage I area.
